UNDERSTANDING GAS ULTRASONIC METER DIAGNOSTICS – ADVANCED

John Lansing
Lansing Measurement Services, LLC

This paper discusses advanced diagnostic features of gas ultrasonic meters (USMs), and how capabilities built into today's electronics can identify problems that may have gone undetected in the past. It primarily discusses fiscal-quality, multipath USMs and does not cover issues that may be different with non-fiscal meters as they are often single path designs. Although USMs basically work the same, the diagnostics for each manufacturer does vary. All brands provide basic features as discussed in AGA Report No. 9 [Ref 1], also known as AGA 9. However, some provide more advanced features that can be used to help identify issues such as blocked flow conditioners, liquids, and gas compositional errors. This paper focuses on the Westinghouse and British Gas configurations (both being four-path chordal designs), and the information presented here may or may not be applicable to other path designs.

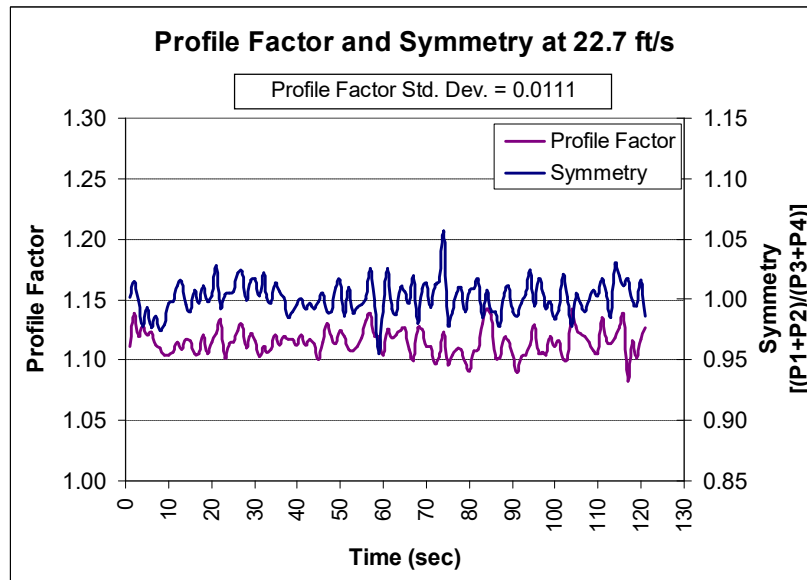
Figure 2 – Profile Factor and Symmetry at 22.7 fps

Another method used to analyze path velocities is to compare the sum of paths 1 & 2 to the sum of paths 3 & 4. This provides a look at the symmetry of the profile from top to bottom and is called **Symmetry**. Normally the meter's path velocities will be very symmetrical resulting in a value close to 1.000. Figures 2 and 3 show both the Profile and the Symmetry in a single graph.

In Figure 2, when the meter was flowing at 23 fps, the Profile Factor was 1.115 (average of the magenta-colored line). As the velocity dropped to 2.8 fps (Figure 3) the Profile Factor increased to 1.137. This is about a 2% change in profile when compared to the Profile Factor at 23 fps.

The other diagnostic worth reviewing is the Symmetry value. Figure 3 shows a significant change (on the order of 10%) in the Symmetry at the lower velocities. This can be seen by comparing the blue line in Figure 2 to the blue line in Figure 3. However, there was no significant impact on meter performance at the time of calibration. These graphs indicate there was a change in the meter’s profile and this is to be expected at lower gas velocities.

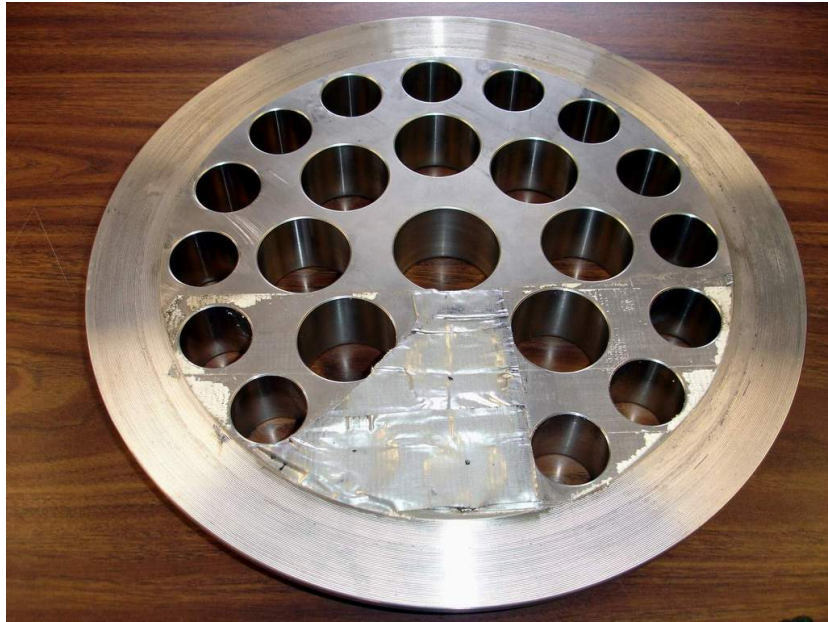
Figure 10 – 3 Holes Blocked Flow Conditioner

In the past many have believed that looking at the Profile Factor alone would be a good indication if any contamination or flow conditioner blockage existed. This may not always be true. Figure 10 shows a picture of a flow conditioner with 3 holes blocked at the bottom.

In this test the three blocked holes in the flow conditioner were located at the bottom of the meter run. This is the same 12-inch meter and testing as discussed with the 40% blockage. Figure 11 shows a graph of the Path Ratios during this test with the 3 blocked holes located at the bottom of the meter piping.

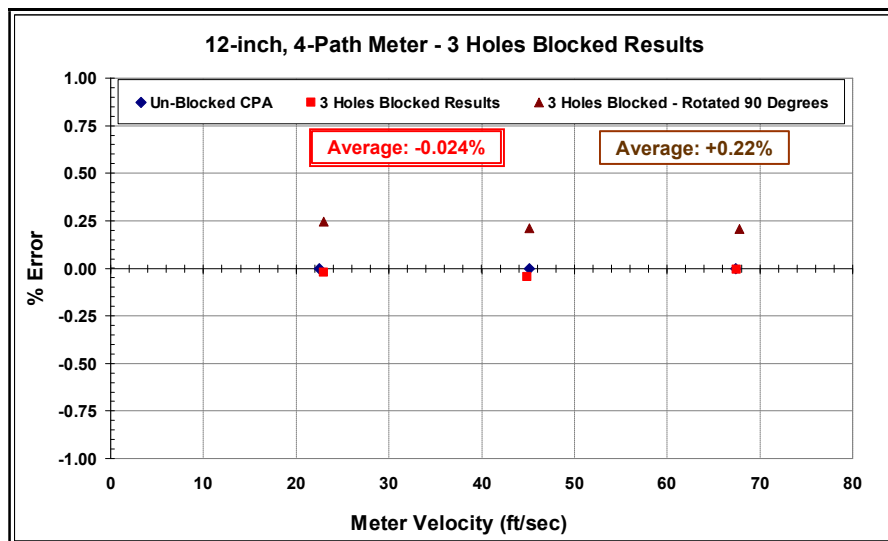
Figure 13 – As-Found Results – 3-Holes Blocked – CPA Rotated 90°

Figure 13 shows what the affect on the meter’s accuracy when this blockage was located at the bottom, and rotated 90 degrees so the blockage affected paths 2 & 3 more significantly (than when it was at the bottom of the pipe).

When the blockage was at the bottom of the meter run, there was very little impact on accuracy (on average -0.024%). When the blockage was rotated 90 degrees to the side, the meter responded with a shift of about +0.22%. All other blockage tests to date had shown the meter responded with a negative shift in error, but for the first time the meter now measured fast with this blockage.

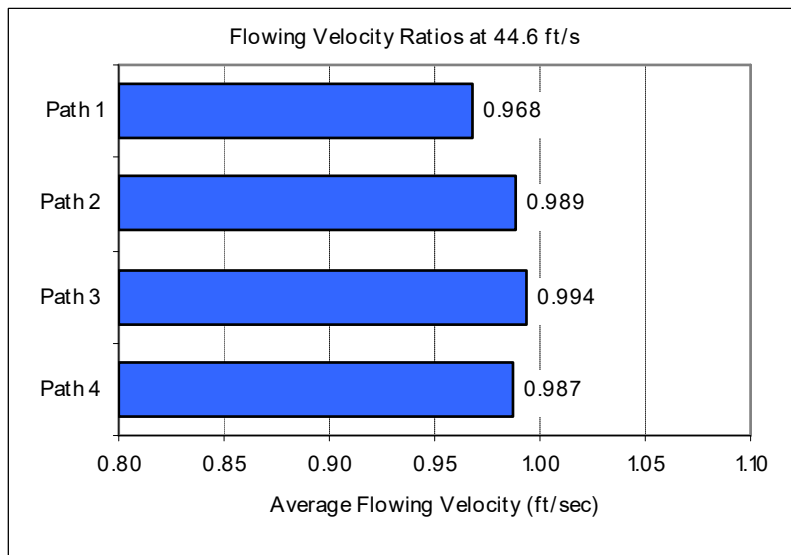
Figure 14 – Path Ratios with 3 Holes Blocked – CPA Rotated 90°

Figure 14 shows that the velocity profile is much flatter than normal. That is the center two paths (paths 2 & 3) are reading much less than normal and are almost the same as the outer paths (2 & 3). This makes sense since the blockage was in direct line with the middle two paths when it was rotated 90 degrees vs. blocking primarily the bottom path when at the bottom.

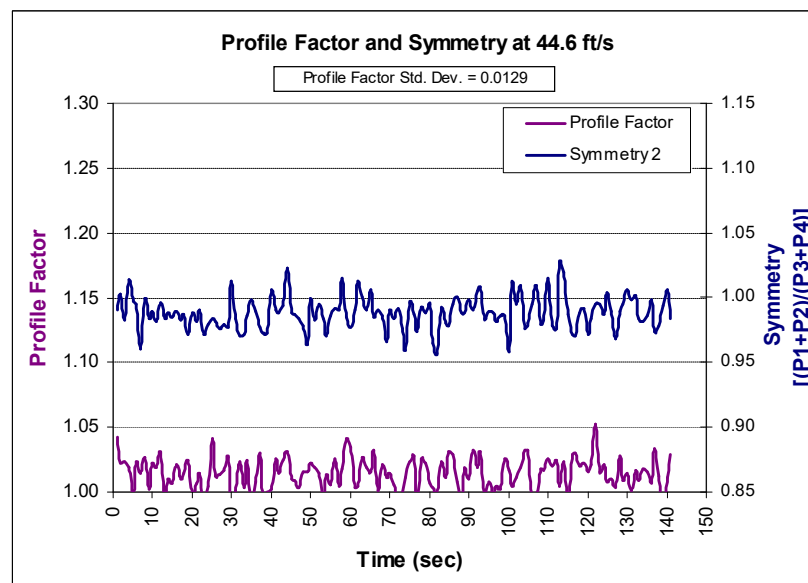
Figure 15 – Profile Factor and Symmetry – 3-Holes Blocked – CPA Rotated 90°

When analyzing the Profile Factor and Symmetry a rather interesting result is apparent. Figure 15 shows a graph of the Profile Factor and Symmetry for the 3-hole blockage on the side.

Figure 15 shows that the average Symmetry is almost normal (0.985, or about 1.5% change from ideal), but the average Profile Factor is 1.011, or about a 10% change. If only Symmetry alone was monitored, a shift of 1.5% would not be considered significant. Thus, a problem might be over-looked.

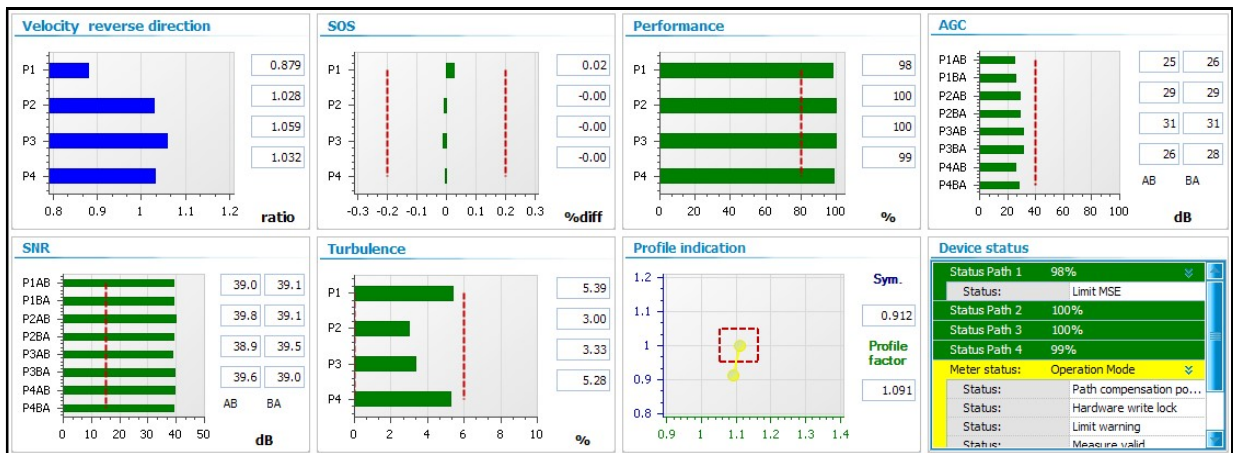
Figure 17 – Summary of All Diagnostics – Abnormal Velocity Profile

In Figure 16 we see a very symmetrical velocity profile (upper left corner). In Figure 17 we see a distorted velocity profile. The Profile Factor and Symmetry are shown in the graph called Profile Indication. It is the 3rd graph from the left on the second row. In Figure 16 we can see there are two dots inside the red box and in Figure 17 we see that one of the dots is outside the red box and the line is yellow. This is telling us the Symmetry is outside of normal tolerances.

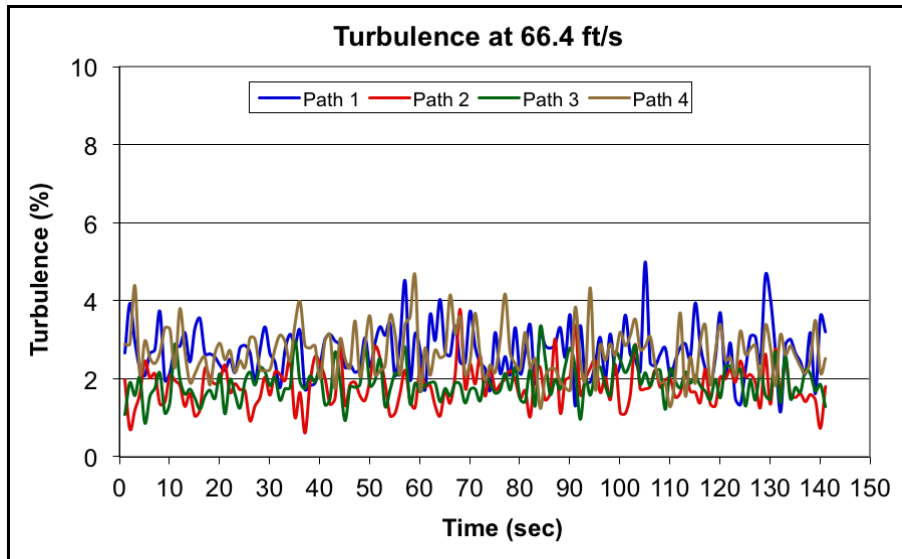
Figure 20 – Normal 12-inch Meter Turbulence

The 12-inch meter in Figure 20 shows a very consistent level of Turbulence during the period of the test. It was collected at the time of calibration and the velocity was about 66 fps. The average for these is 2.44% and this is considered normal.

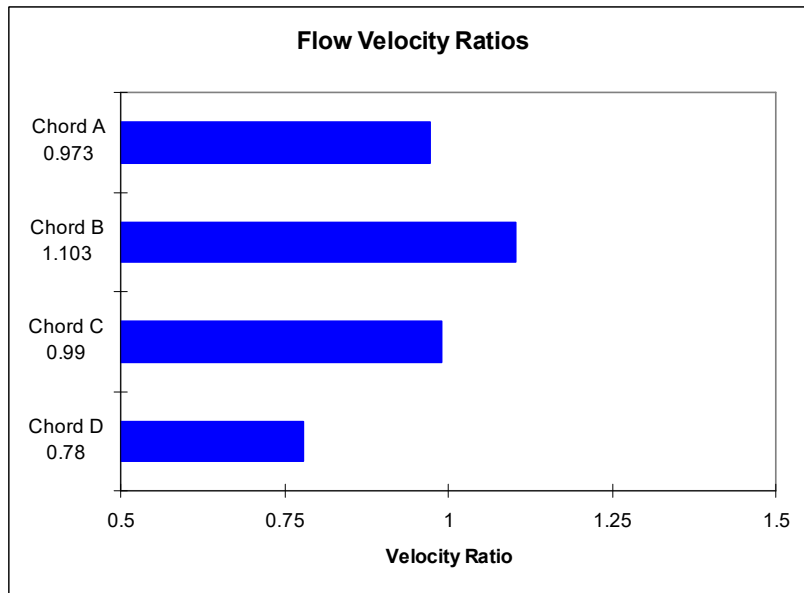
Figure 22 – 12-inch Meter with Distorted Profile

The following figure shows another example of a distorted velocity profile. This is a 12-inch meter graph taken at the time of a monthly inspection.

The graph shows a low velocity at the bottom of the meter. This is most likely caused by contamination in front of the flow conditioner. To validate this assumption, Turbulence should also be high. The following graph shows the turbulence for this meter.

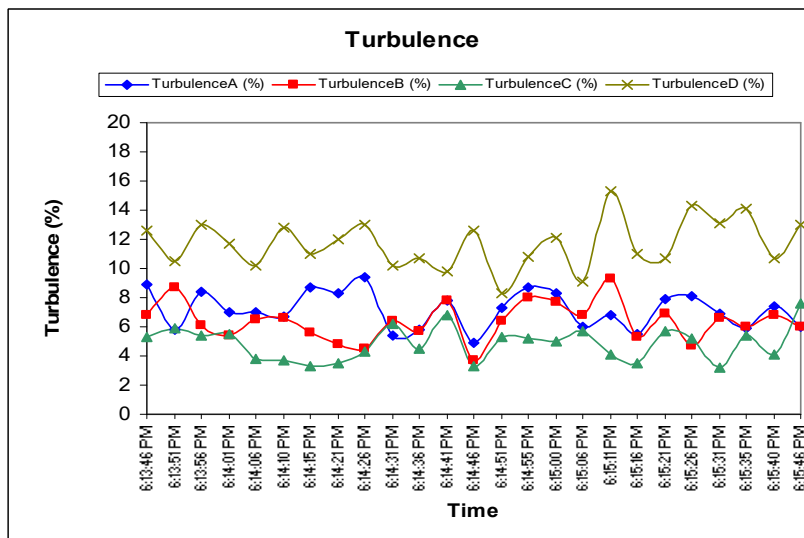
Figure 23 – 12-inch Meter with High Turbulence

Figure 23 shows all the turbulence values are significantly above the normal values that are 3-4%. Since all Turbulences are high, there must be something blocking the flow conditioner. Figure 24 shows the results from the manufacturer's software with the profile analysis. Show is the Profile Factor, Symmetry and Crossflow results.

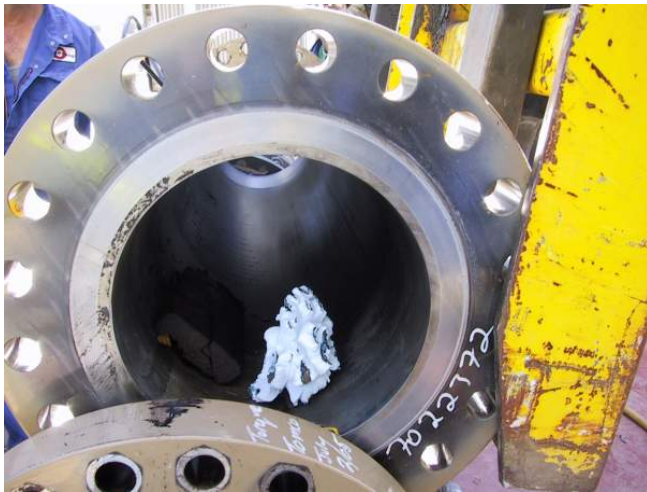
Figure 25 – 12-inch Flow Conditioner Blockage

Figures 25 and 26 show the debris that was in front of the flow conditioner. These two items caused the distorted profile and high turbulence. Figure 27 shows the Path Ratios after the debris is removed, and Figure 28 shows the Turbulence values that have now returned to normal.

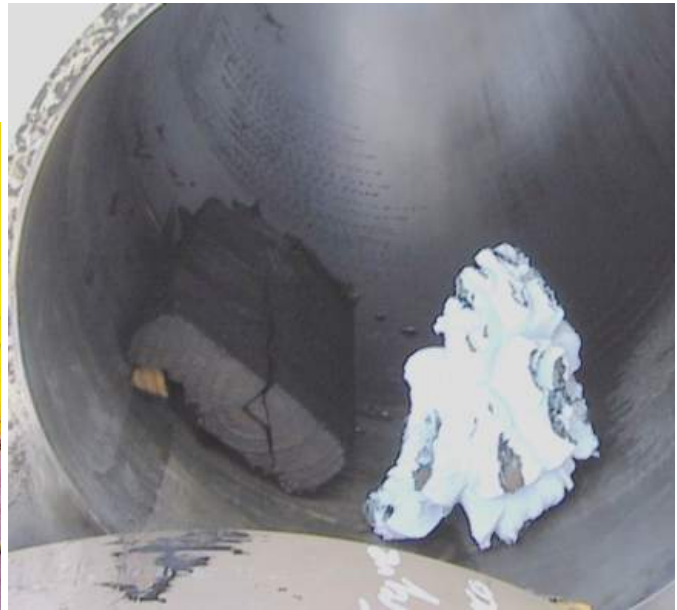
Figure 26 – 12-inch Flow Conditioner Blockage

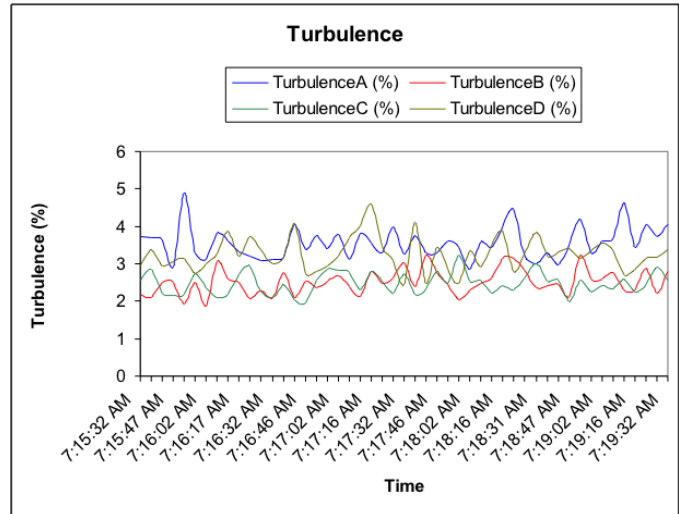
Figure 28 – 12-inch Meter With Normal Turbulence

Once the debris has been removed, all the meter’s diagnostics have returned to normal. All Chord Ratios in Figure 27 have returned to normal, the Turbulence values in Figure 28 are typical, and the Profile Factor, Symmetry and Crossflow values in Figure 29 are all normal.

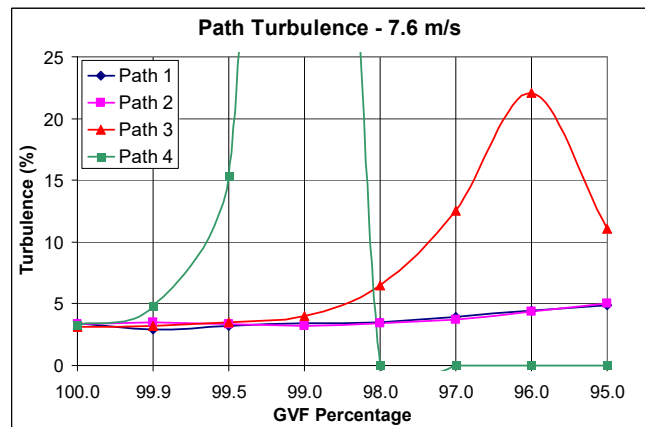
Figure 33 – 4-inch Turbulence

Figure 32 shows something different is happening with per-path SOS. The SOS on Path 4 is now going slower relative to the other three paths. This might be the reverse of "common wisdom" since the SOS in liquid is higher than gas, and at this point probably mostly at the bottom of the meter. Now there are three distinctly different looking graphs of diagnostics telling us there is a problem. When these are combined with the final diagnostic, Turbulence, it is clear liquids are present. Figure 33 shows the sensitivity of Path 4 Turbulence for even the slightest amount of liquids. The important part of the Turbulence graph is that only Path 4 turbulence has increased significantly compared to all the

others (which remain relatively normal until very high levels of liquid are present). This is further confirmation that liquids are present.
